Re: State Project: R-2530B

NC 24-27 from Bird Road in Albemarle to West of the Pee Dee River

Subject: Preliminary Site Assessment

Parcel #122 – Vernon E, Furr & S F Winslow (Castaways)

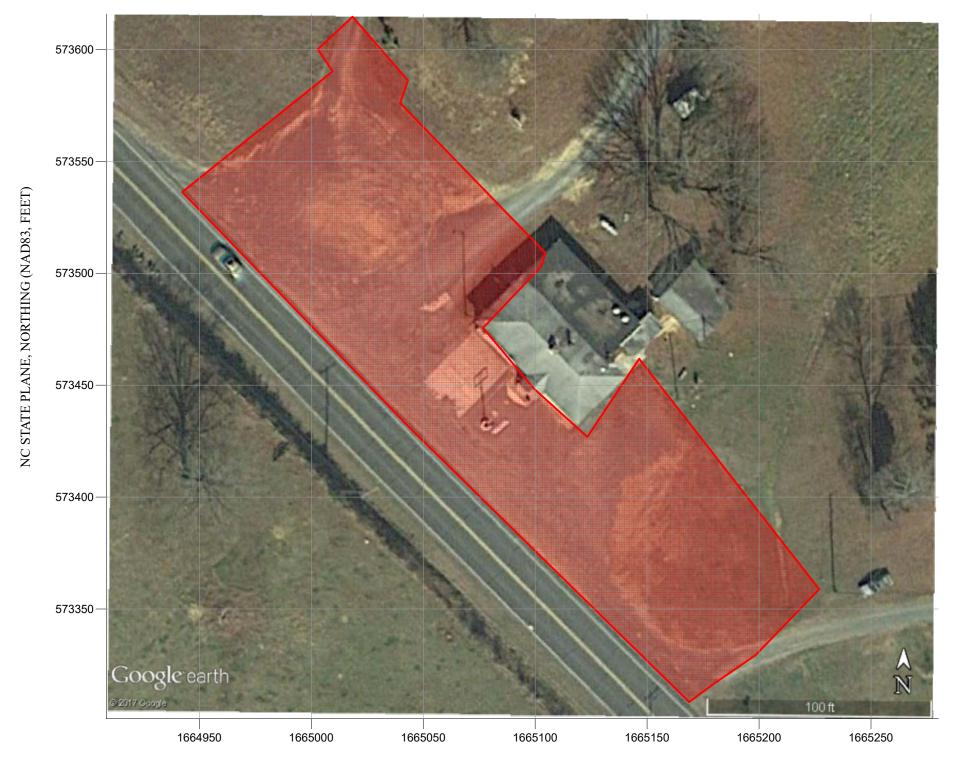
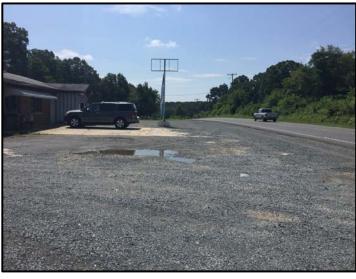
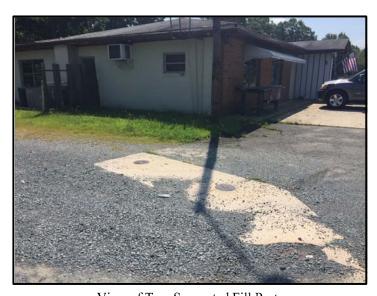
PARCEL 122 - GEOPHYSICAL SURVEY BOUNDARIES AND SITE PHOTOGRAPHS

The site included a commercial building surrounded by a gravel parking area and grass medians. An aerial photograph showing the survey area boundaries and ground-level photographs are shown in **Figure 1**.

View of Survey Area (Facing Approximately Southeast)

View of Two Suspected Fill Ports (Facing Approximately Southeast)

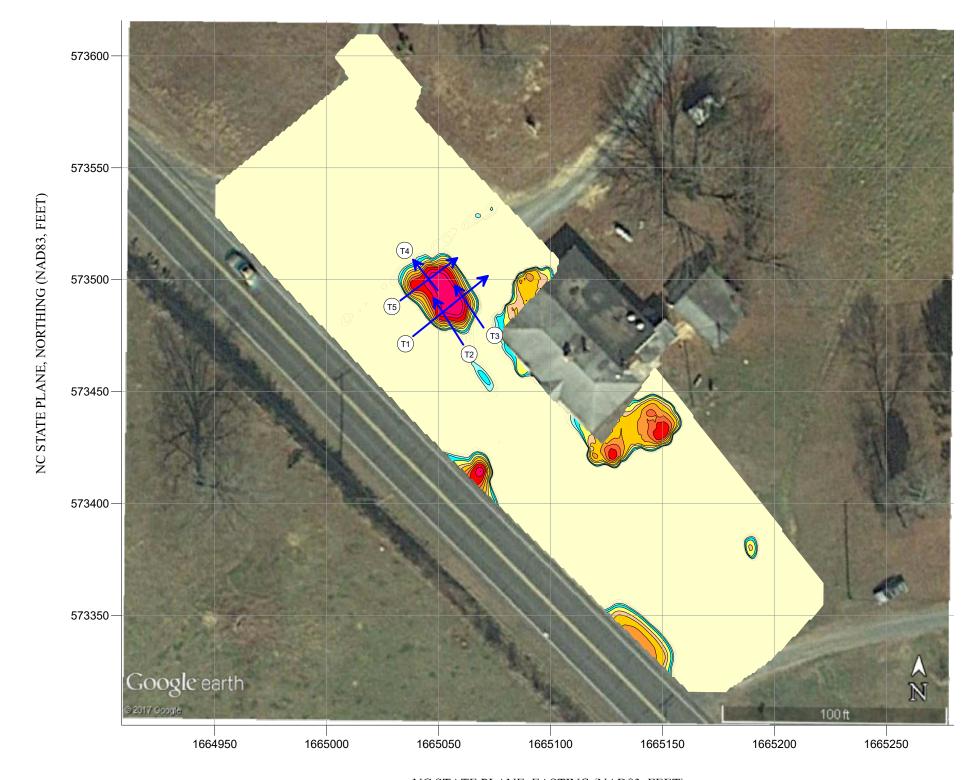
PARCEL 122 -GPR TRANSECT LOCATIONS AND IMAGES

Figure 3 presents the locations of the formal GPR transects performed at the property, as well as the transect images. A total of five GPR transects were performed at the site. GPR Transects 1-5 were performed across Anomaly 1 on the west side of the building. These transects showed three isolated hyperbolic reflectors and three discreet lateral reflectors that are characteristic of metal USTs. The combined EM and GPR data result in these features being classified as three probable USTs (center points: northwest tank – 1665044, 573501, southwest tank – 1665052, 573489, southeast tank – 1665057, 573493 North Carolina State Plane NAD83, feet). The two southern probable USTs were approximately 21 feet long and 6 feet wide at depths of approximately 2 feet below the ground surface. The north probable UST was approximately 18 feet long and 6 feet wide at a depth of approximately 2 feet below the ground surface. **Figure 4** presents the locations of the probable USTs on an aerial photograph along with a ground-level photograph.

- GPR provided evidence of three isolated hyperbolic reflectors and three discreet lateral reflectors on the west side of the building that are characteristic of USTs. The combined geophysical data resulted in these features being classified as three probable metallic USTs (center points: northwest tank 1665044, 573501, southwest tank 1665052, 573489, southeast tank 1665057, 573493 North Carolina State Plane NAD83, feet).

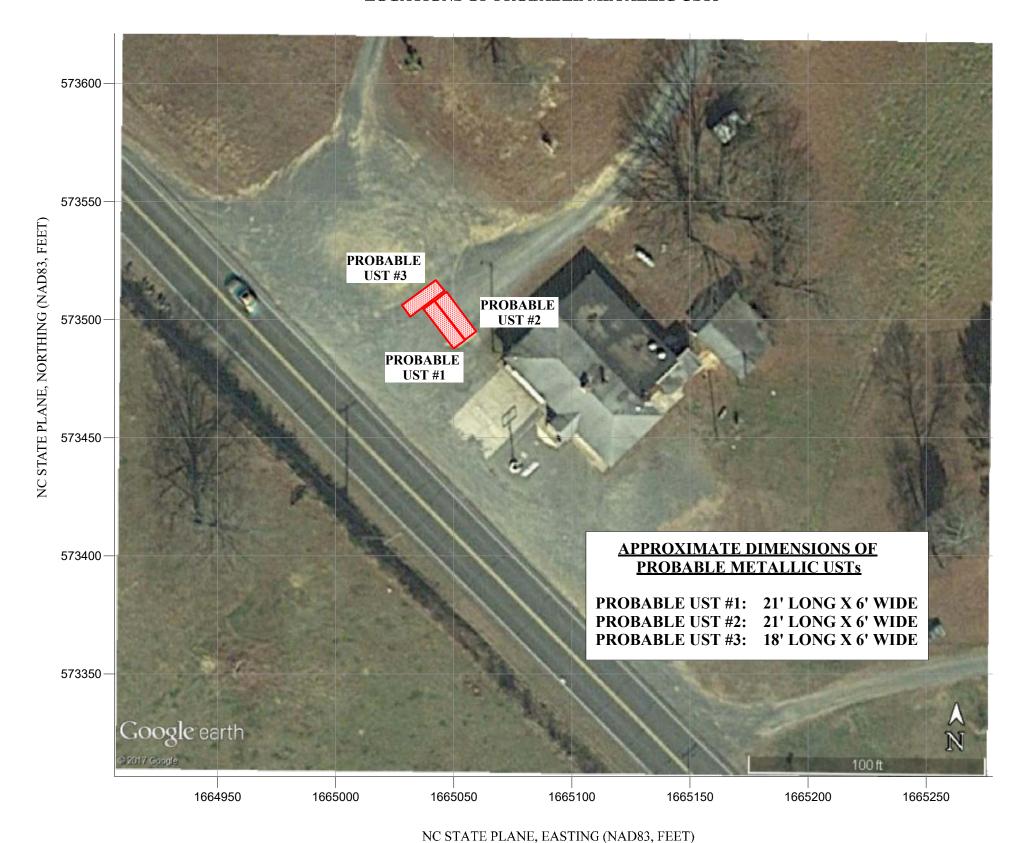
PARCEL 122 -LOCATIONS AND SIZES OF PROBABLE USTs

- The two southern probable USTs were approximately 21 feet long and 6 feet wide at depths of approximately 2 feet below the ground surface.
- The north probable UST was approximately 18 feet long and 6 feet wide at a depth of approximately 2 feet below the ground surface.

View of Three Probable USTs Facing Approximately Northeast

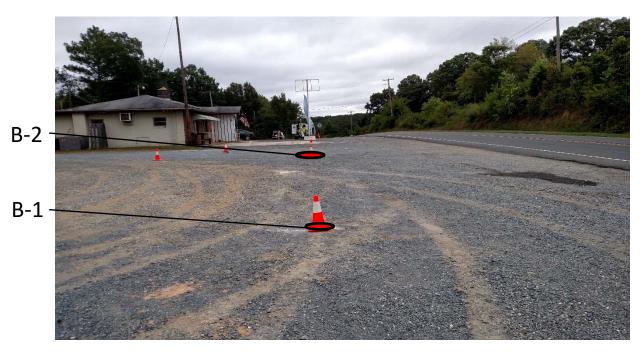
Photo #1: Boring locations B-1 and B-2, facing southeast.

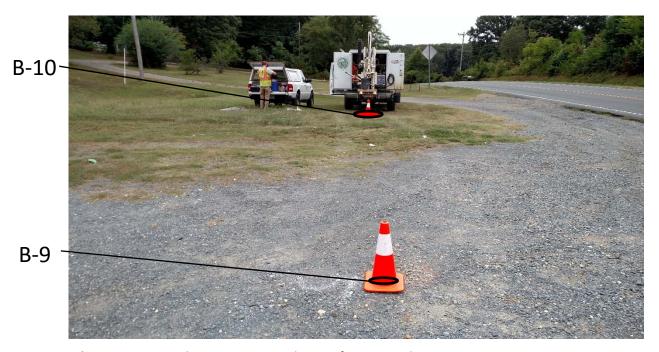
Photo #4: Boring locations B-9 and B-10, facing southeast.
